# LOWER WALLER CREEK FIELD GUIDE

15TH STREET TO LADY BIRD LAKE ~ AUGUST 18, 2008

WATERSHED PROTECTION AND DEVELOPMENT REVIEW DEPARTMENT  
ENVIRONMENTAL RESOURCE MANAGEMENT DIVISION

THE WATERSHED PROTECTION, ENVIRONMENTAL RESOURCE MANAGEMENT STAFF WALKED LOWER WALLER CREEK ON AUGUST 18, 2008 . THIS FIELD GUIDE PROVIDES A VISUAL TOUR OF LOWER WALLER CREEK.

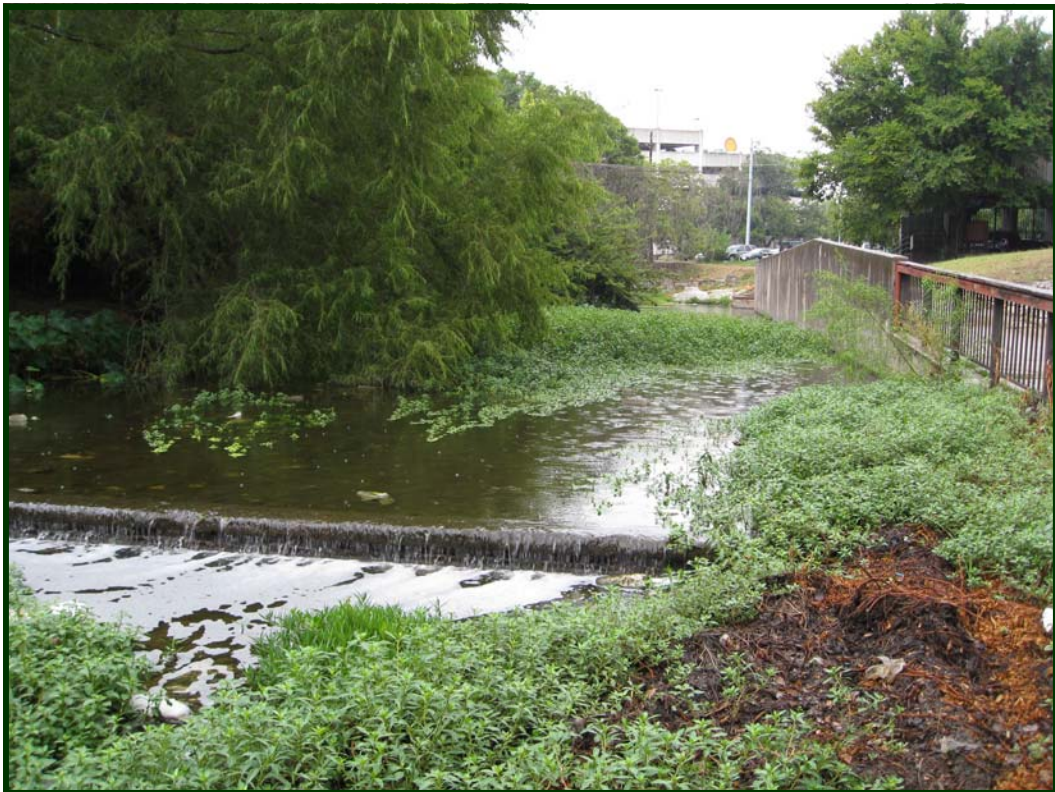
- a) Channel Bed – Rock, Channel Banks – Alluvial and Structural
- b) Channel Stability – low head dam near 8<sup>th</sup> Street causing backwater and some aggradation
- c) Property Ownership – City of Austin (east bank) and Private (west bank)
- d) Creek Erosion Sites – none

PHOTO 22 ~ LOW DAM, LOOKING UPSTREAM

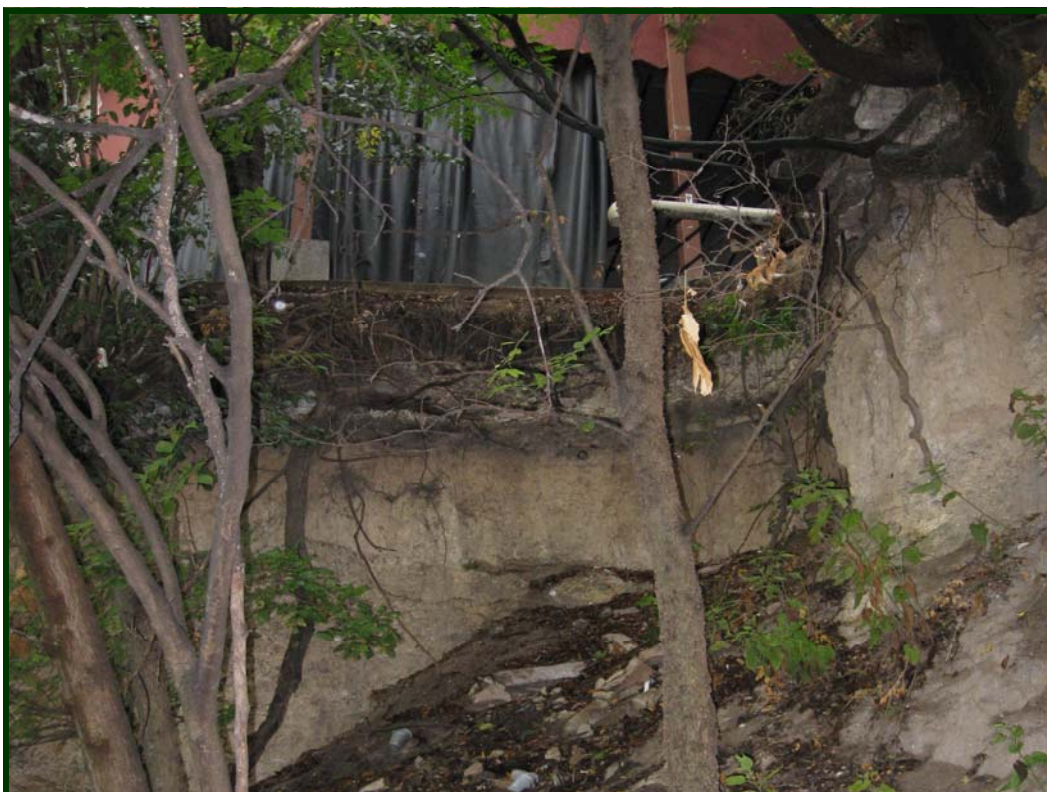
- a) Channel Bed – Rock, Channel Banks – Alluvial and Structural
- b) Channel Stability – Vertically stable, low check dam at 7<sup>th</sup> Street causing backwater and some aggradation, planform adjustment and slope instability causing problems, west bank at Red Eye Fly
- c) Property Ownership – City of Austin (east bank) and Private (west bank)
- d) Creek Erosion Sites – Type 1 Building: imminent threat to Red Eye Fly building. Minor localized site runoff erosion concerns for businesses along E 7<sup>th</sup> Street.

PHOTO 28 ~ BANK EROSION AT THE RED EYED FLY

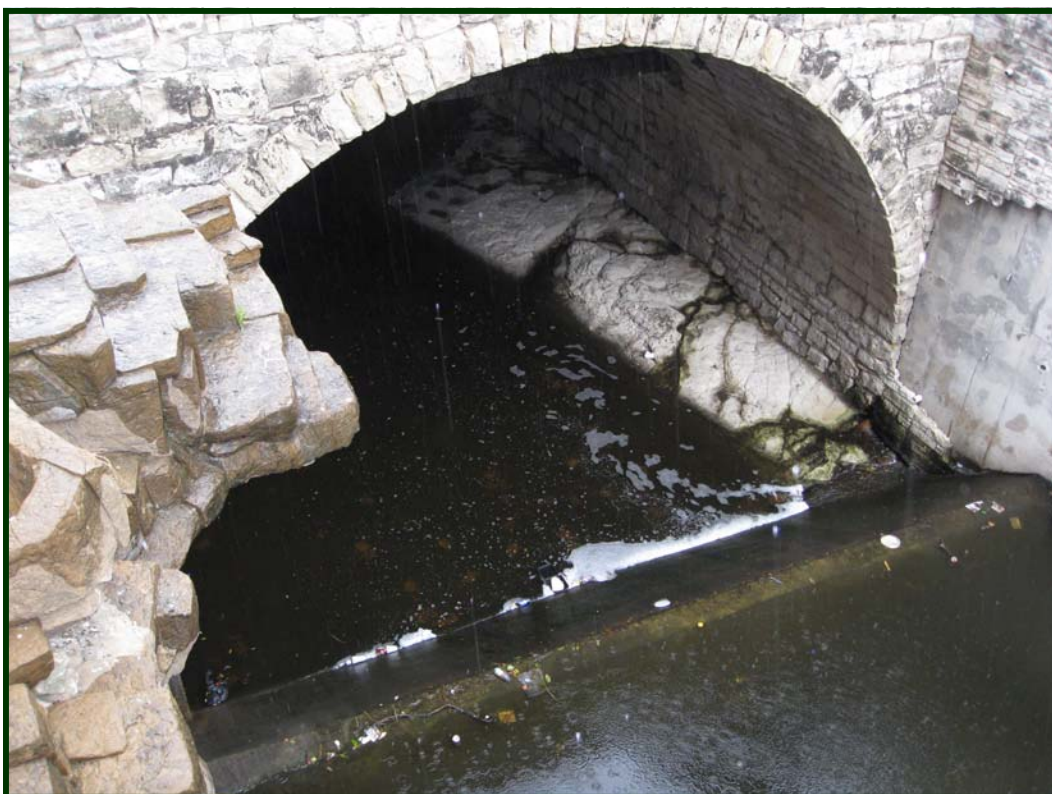
- a) Channel Bed – Rock, Channel Banks – Structural
- b) Channel Stability – Stable, low head dam at 5<sup>th</sup> Street causing backwater
- c) Property Ownership – City of Austin (north) and Private (south)
- d) Creek Erosion Sites – none

PHOTO 38 ~ DAM AT THE 5TH STREET BRIDGE

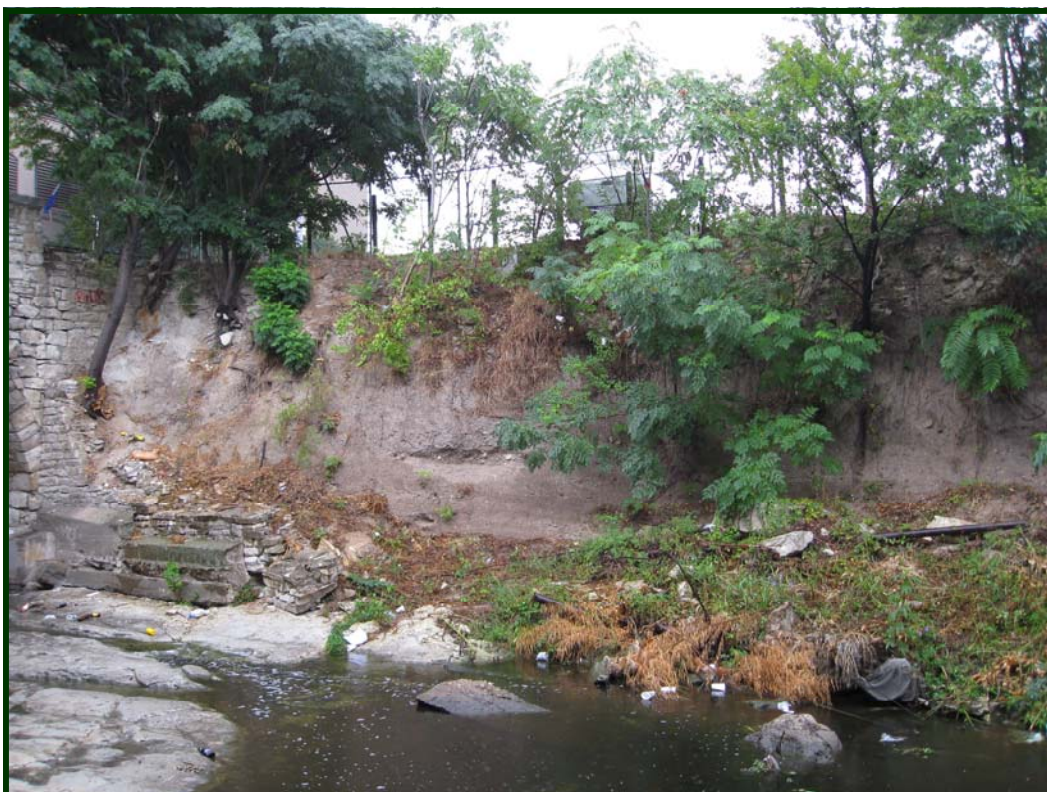
- a) Channel Bed – Alluvial and rubble, Channel Banks – Alluvial
- b) Channel Stability – vertically stable, concrete section at 4<sup>th</sup> Street Bridge provides grade control backwater, planform adjustment and slope instability threatening resources on east bank
- c) Property Ownership – All private with no easements
- d) Creek Erosion Sites – 3 Type 2 Erosion Problems (Parking lot, tree, wall)

PHOTO 40 ~ EAST BANK EROSION AT 5TH STREET BRIDGE

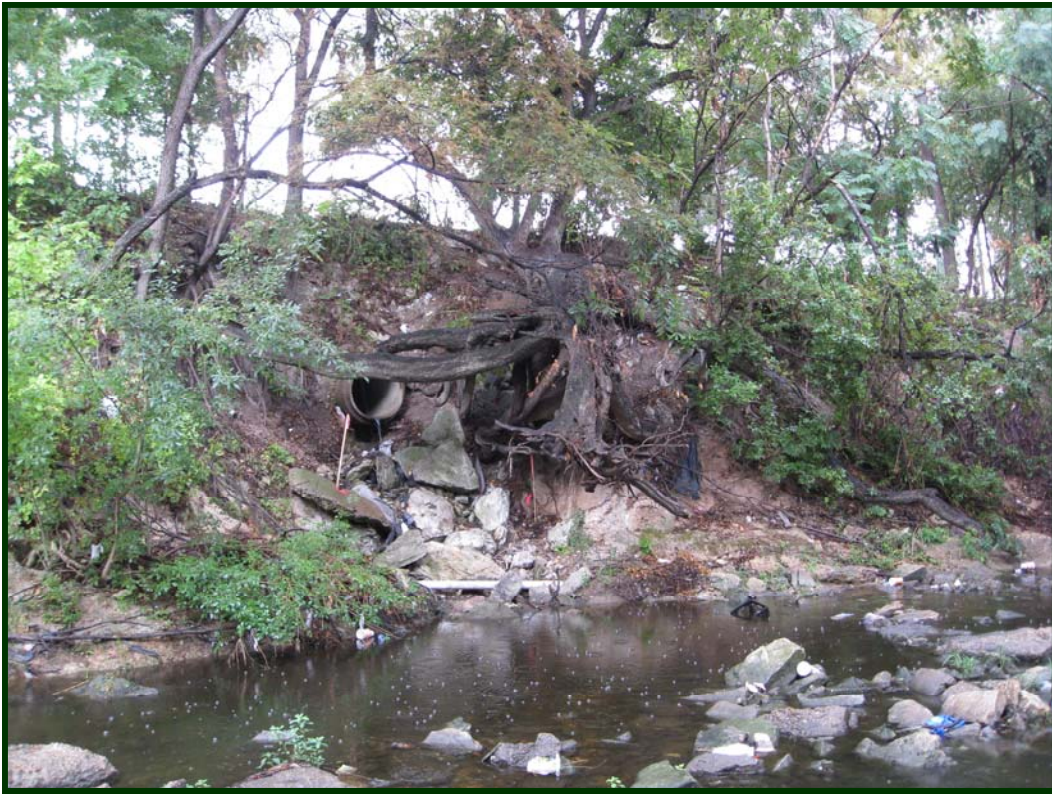
PHOTO 41 ~ EAST BANK EROSION AND STORM DRAIN OUTFALL

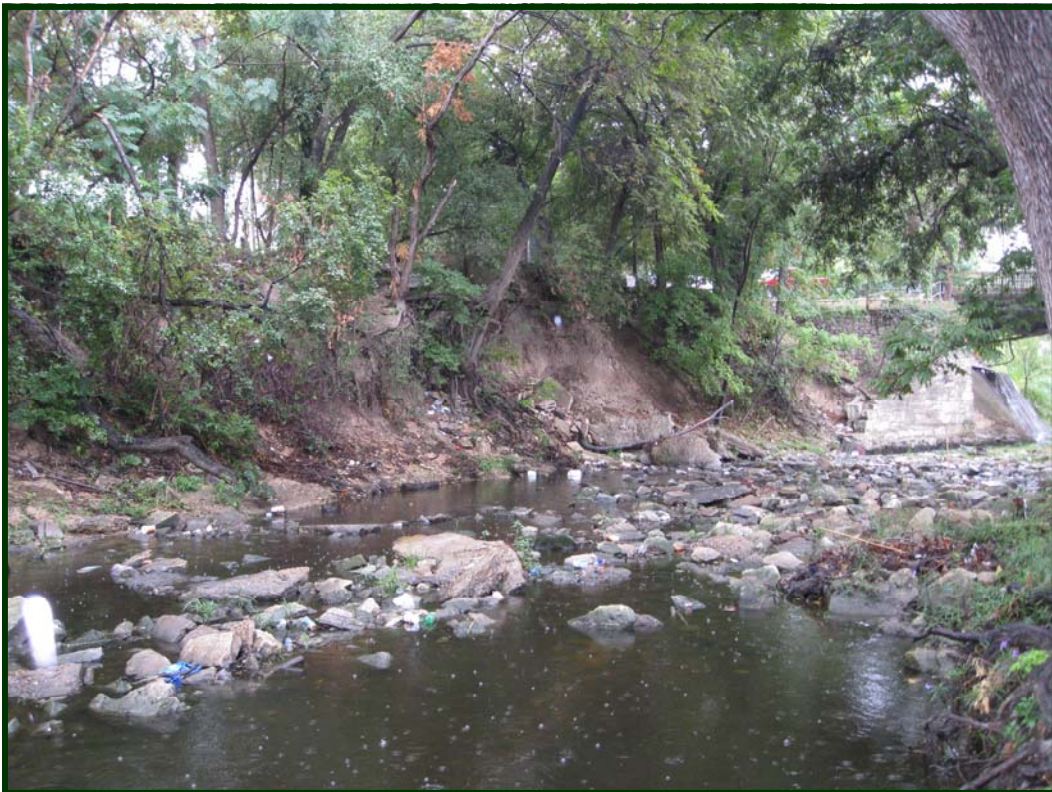
PHOTO 42 ~ EAST BANK EROSION, LOOKING DOWNSTREAM

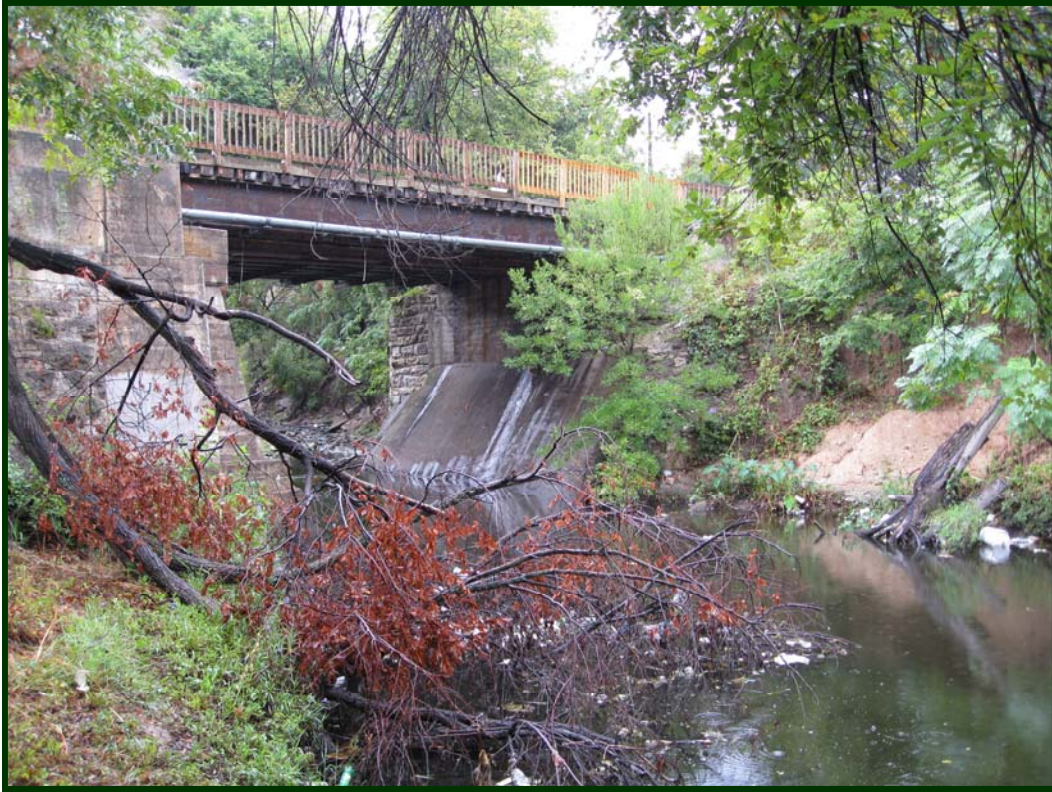
PHOTO 43 ~ 4TH STREET BRIDGE, EAST BANK EROSION,

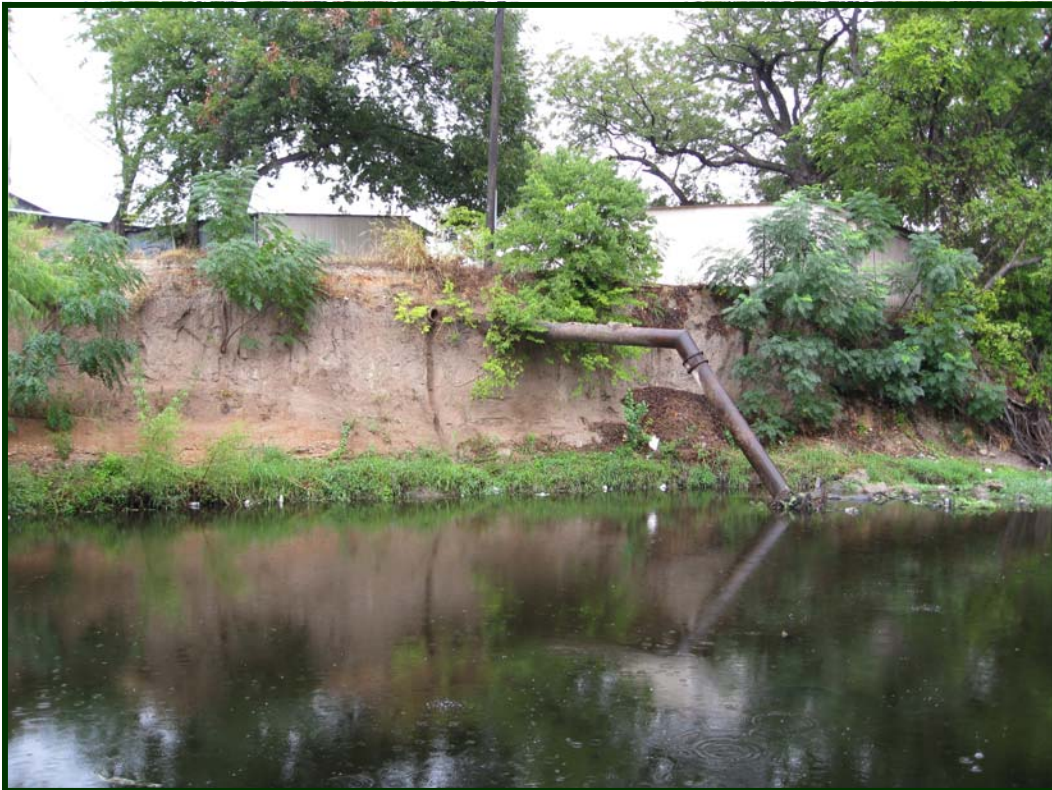
- a) Channel Bed – Alluvial, Channel Banks – Alluvial
- b) Channel Stability – In adjustment (active erosion), active planform adjustment and slope instability threatening resources on both banks
- c) Property Ownership – City of Austin ROW (west bank) and private (east bank)
- d) Creek Erosion Sites – 5 Type 1, 2 and 3 Erosion Problems (Building, Yard, Trail, Bridge)

PHOTO 44 ~ EAST BANK EROSION, EXPOSED PIPE

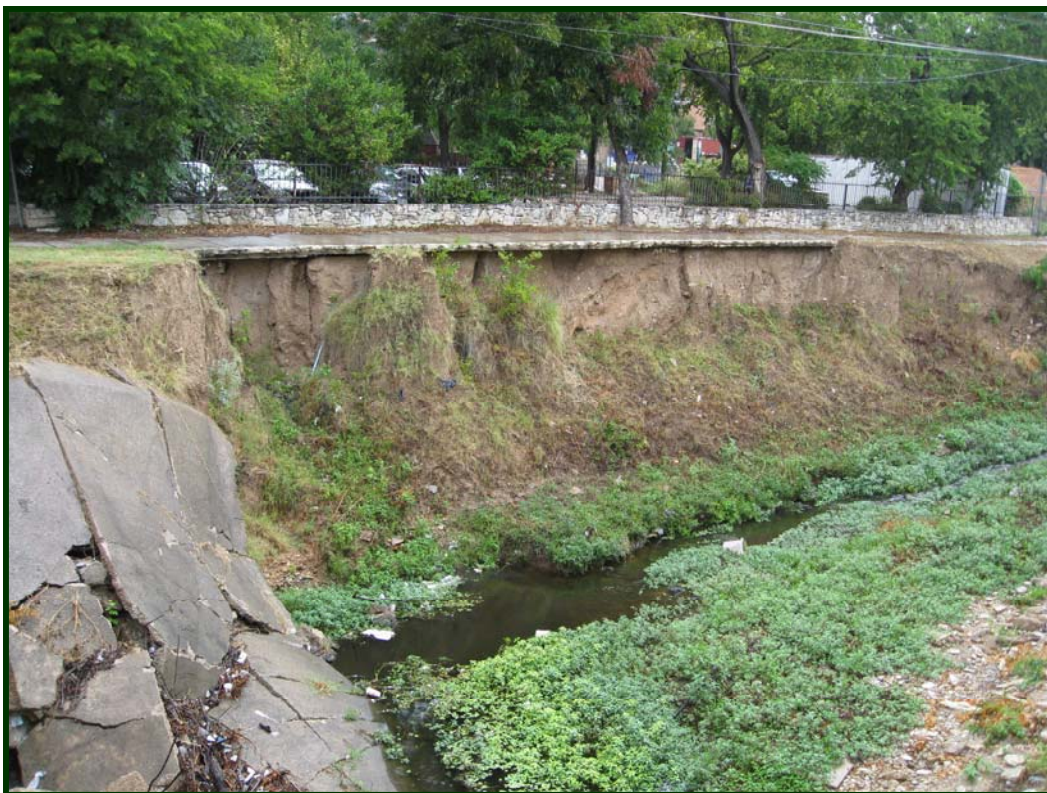
PHOTO 45 ~ WEST BANK EROSION, UNDERMINED TRAIL

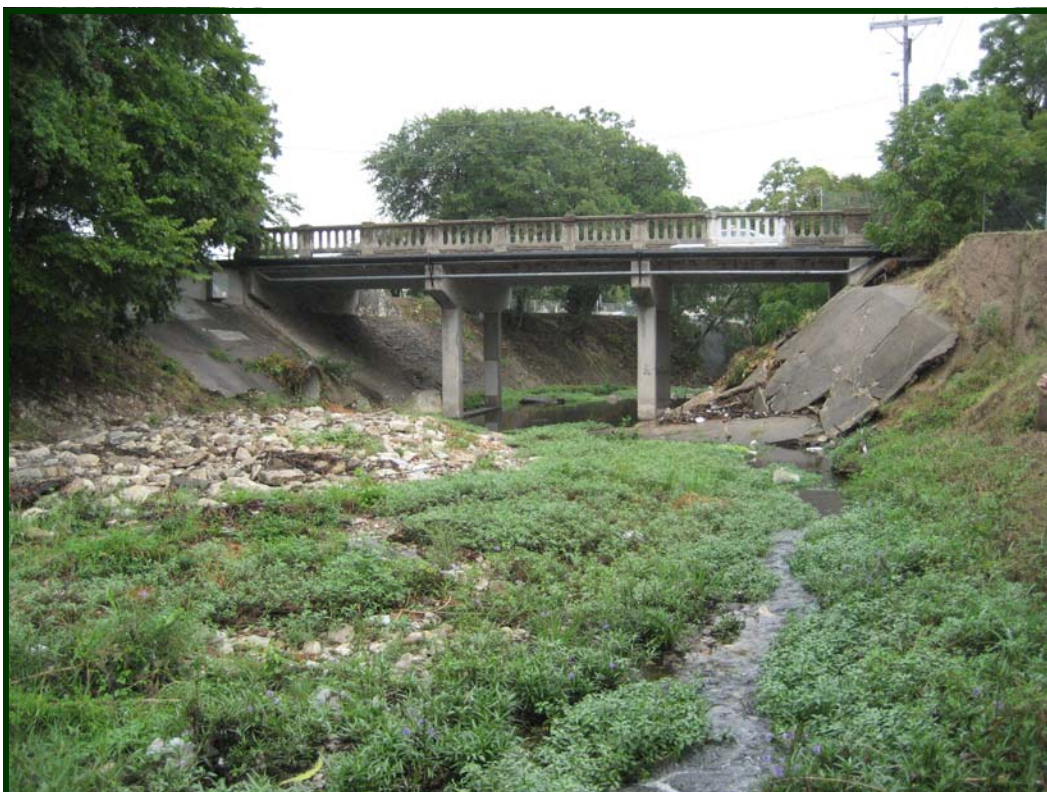
PHOTO 46 ~ 3RD ST. BRIDGE, FAILING CONC, LOOKING DOWNSTRM

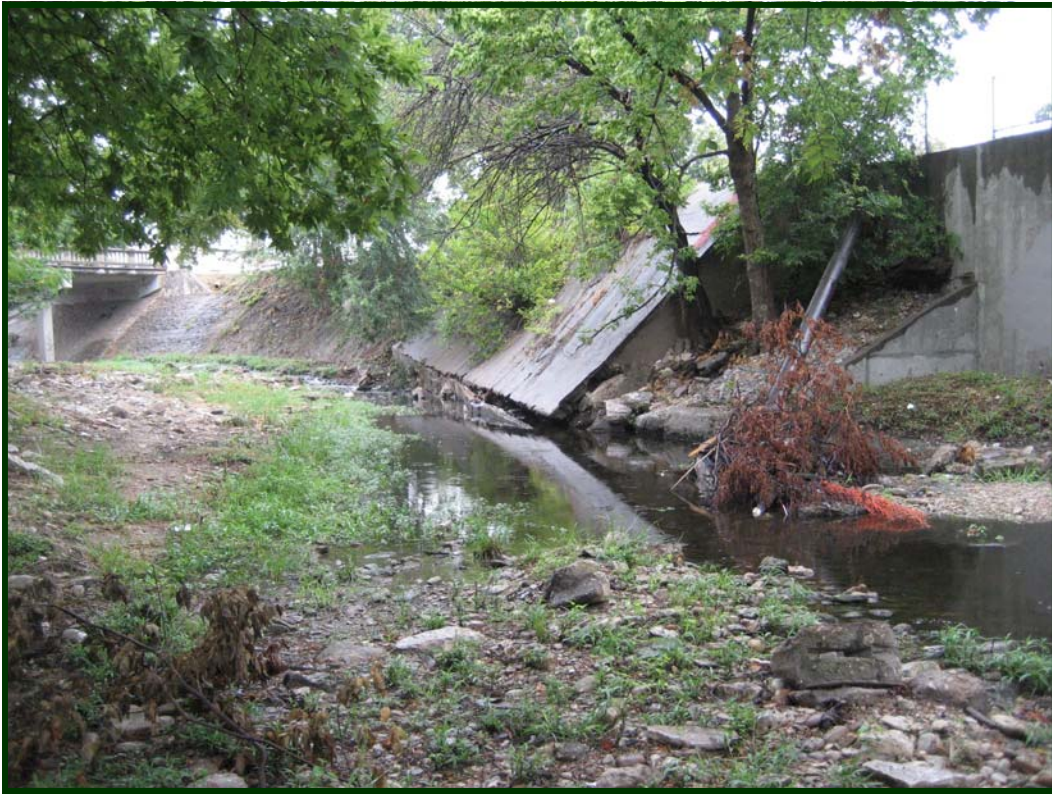
PHOTO 47 ~ 3RD STREET BRIDGE, FAILING CONCRETE

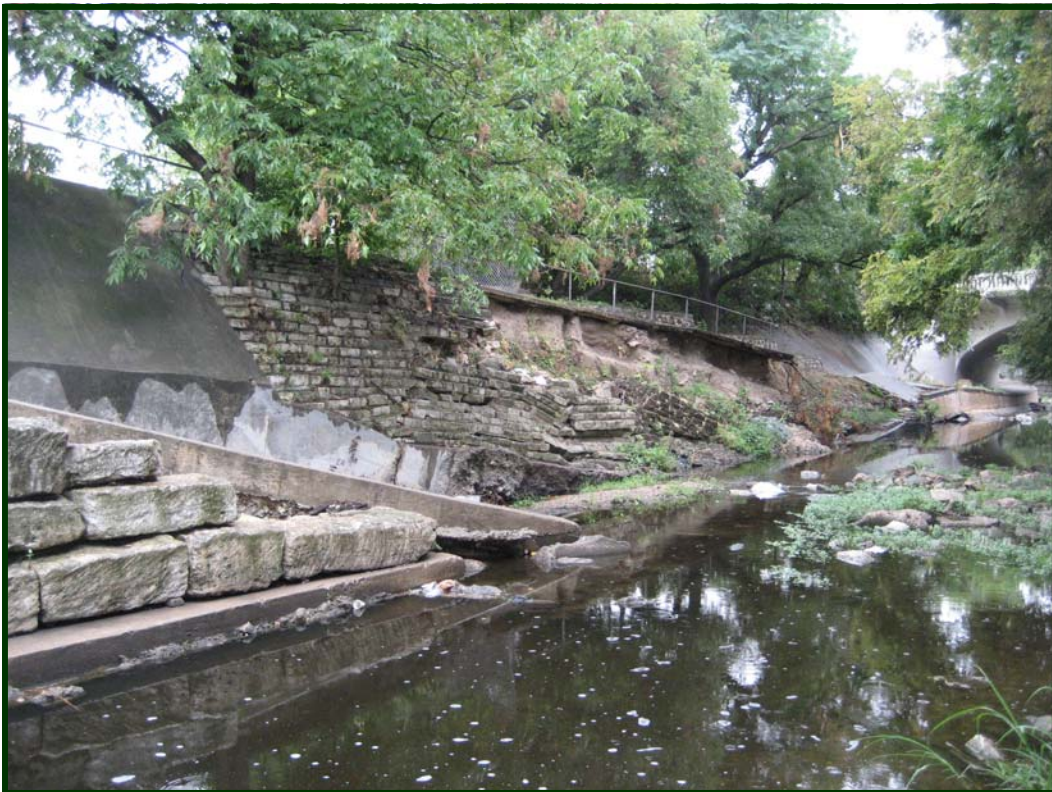
- a) Channel Bed – Alluvial, Channel Banks – Alluvial and Structural (failing)
- b) Channel Stability – In adjustment (active erosion), active planform adjustment and slope instability threatening resources on both banks
- c) Property Ownership – All City of Austin
- d) Creek Erosion Sites – 3 Type 2 and 3 Erosion Problems (Retaining Wall and Trails)

PHOTO 48 ~ EAST BANK EROSION, UNDERMINED TRAIL

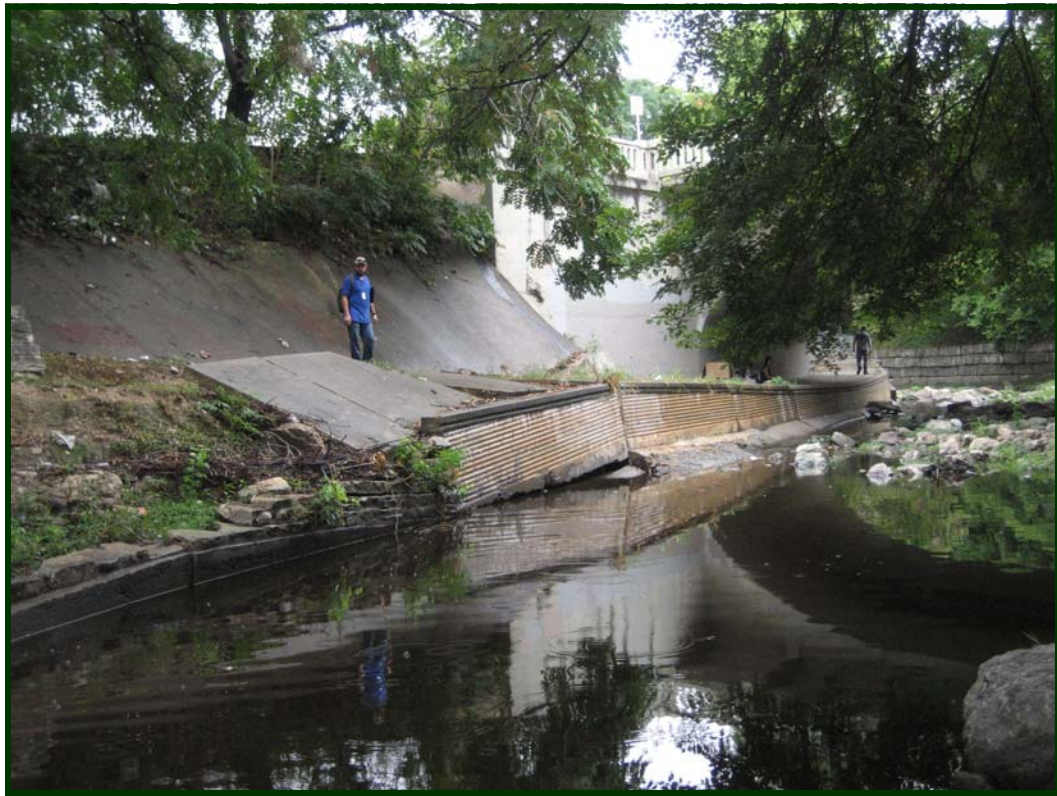
PHOTO 49 ~ EAST BANK EROSION, UNDERMINED CONCRETE

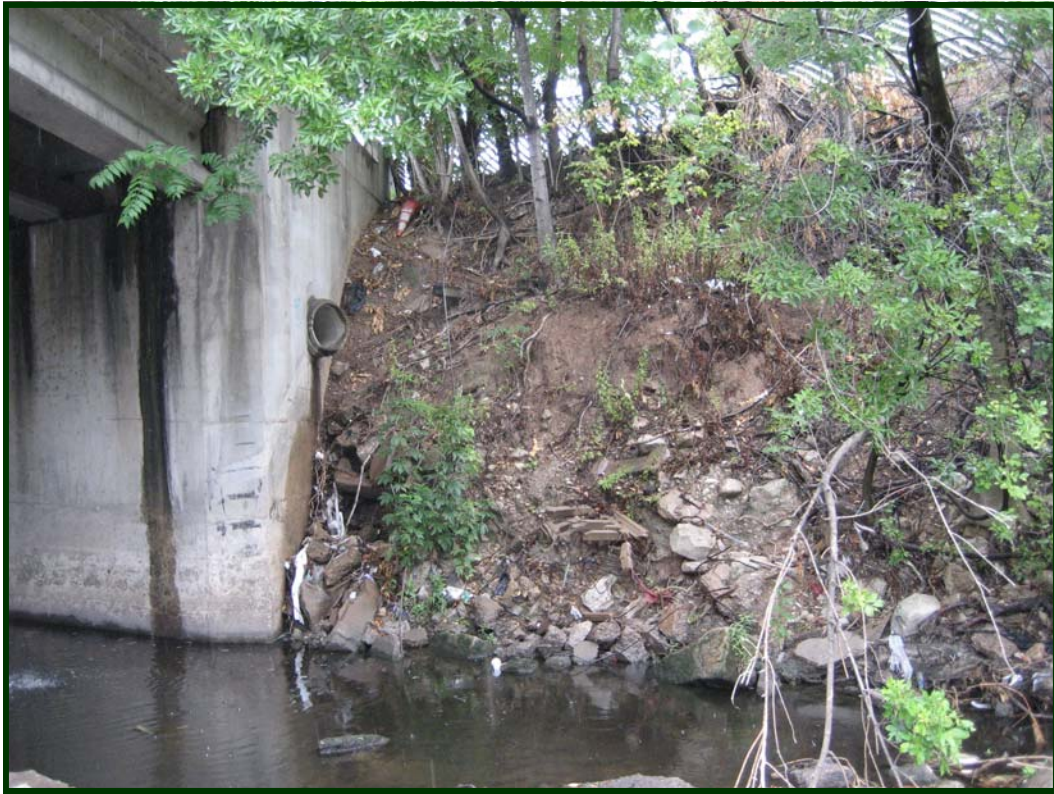
- a) Channel Bed – Alluvial, Channel Banks – Alluvial and Structural
- b) Channel Stability – In Transition becoming more depositional due to backwater from Lady Bird Lake. Large point bar and greater meander migration potential downstream of Cesar Chavez.
- c) Property Ownership – Mostly City of Austin and drainage easements
- d) Creek Erosion Sites – 4 Type 2 and 3 erosion sites including walls and yards

PHOTO 55 ~ CESAR CHAVEZ BRIDGE, EAST BANK EROSION

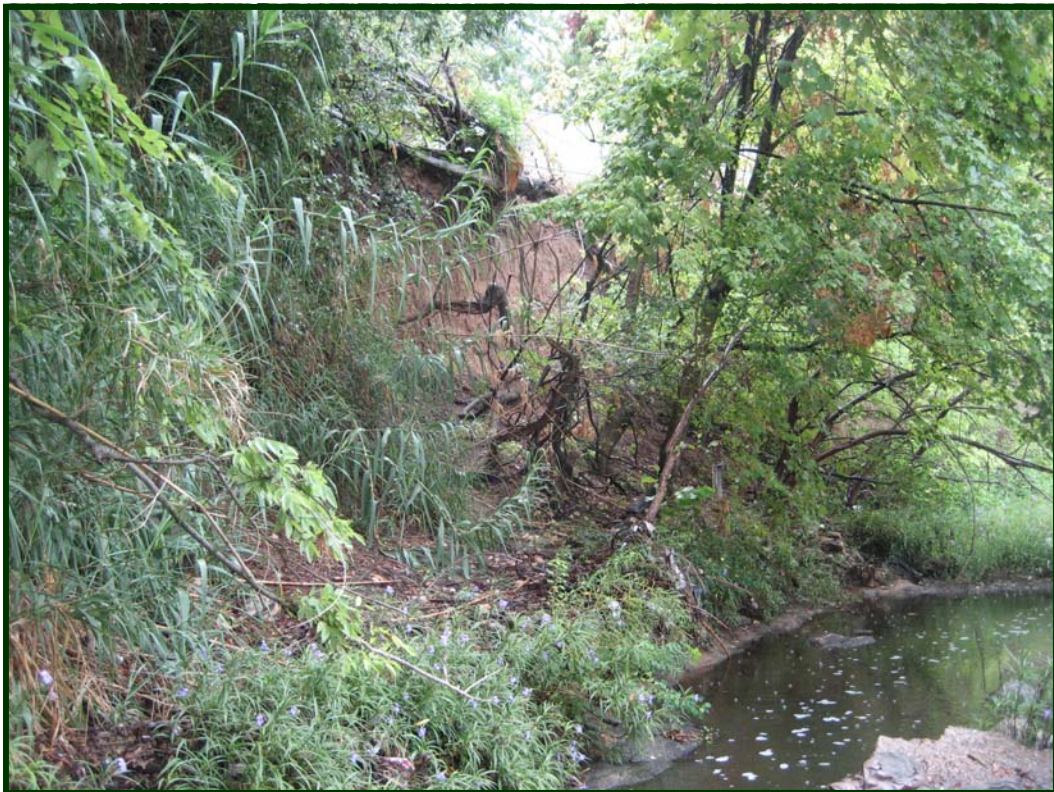
PHOTO 56 ~ EAST BANK EROSION, LOOKING DOWNSTREAM

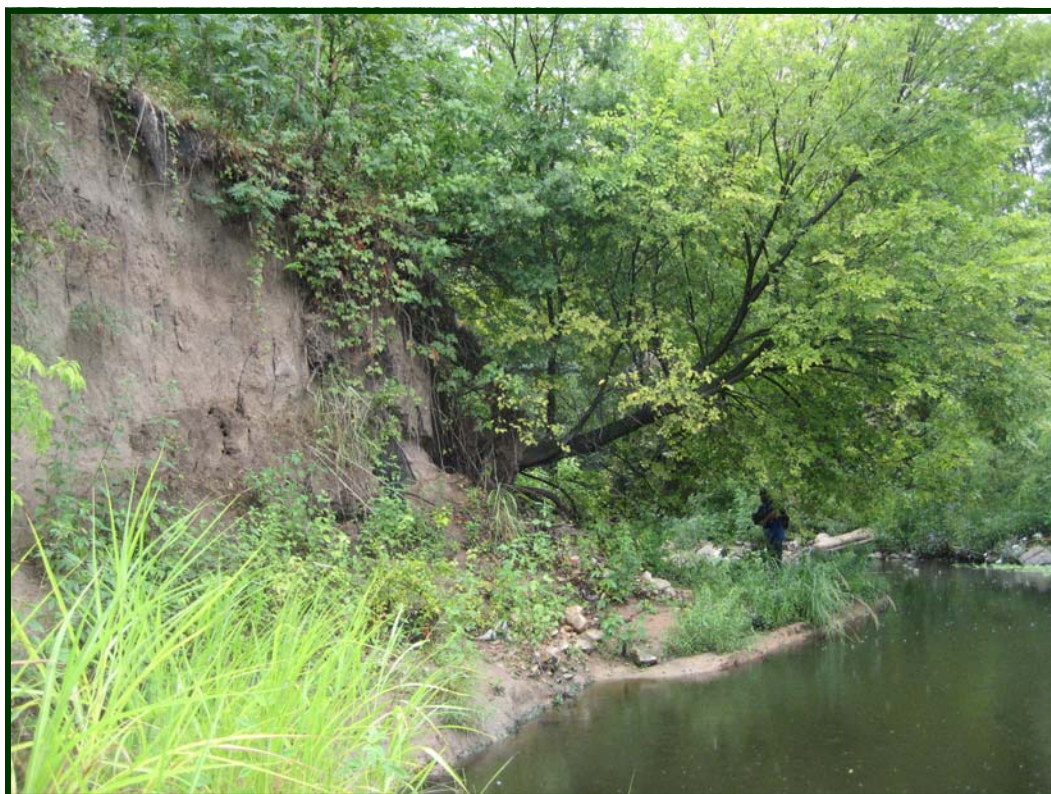
PHOTO 58 ~ EAST BANK EROSION, LOOKING DOWNSTREAM

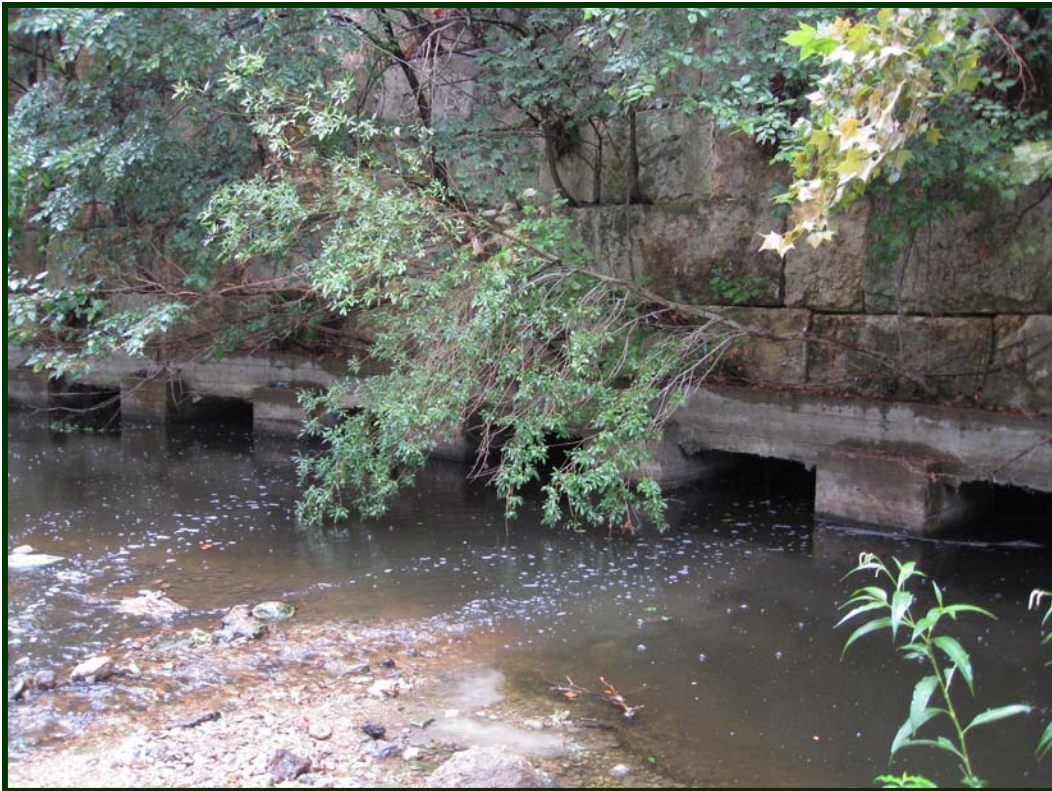
PHOTO 59 ~ WEST BANK, EXPOSED RETAINING WALL FOUNDATION

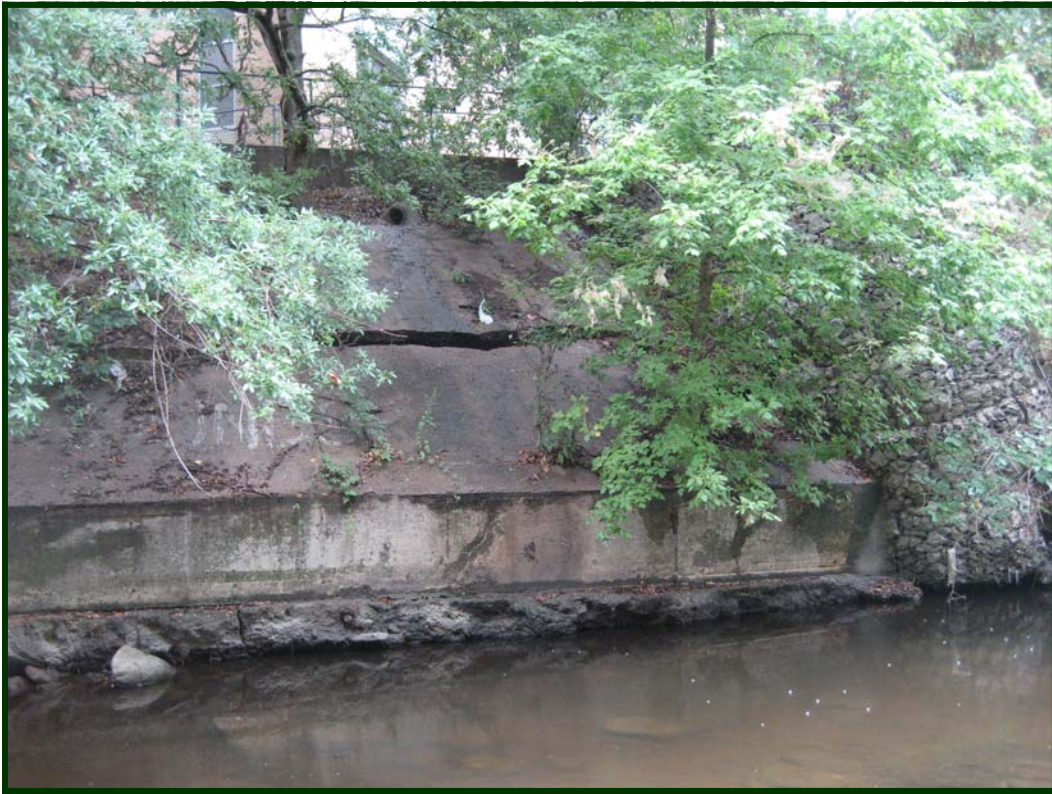
PHOTO 61 ~ WEST BANK, FAILING CONCRETE WALL

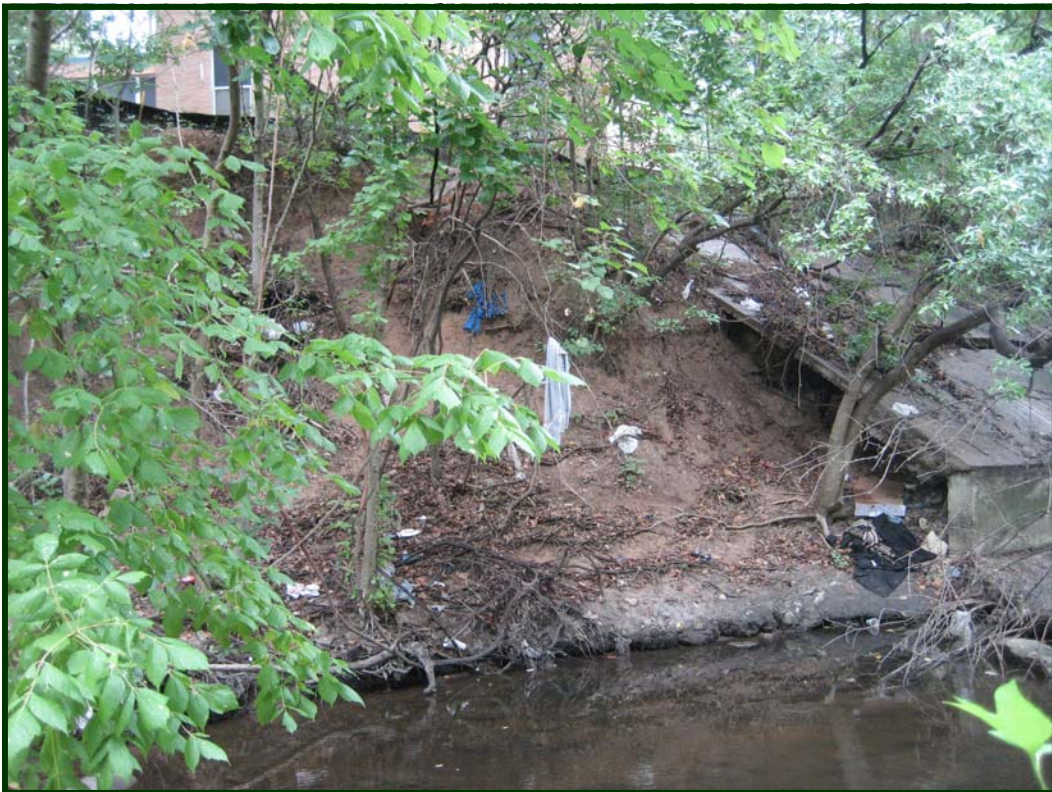
PHOTO 62 ~ WEST BANK EROSION, UNDERMINED CONCRETE
